THE NORTHERN & REMOTE COMMUNITIES ISSUE

FORMULA CONTRACTORS STEPPED IN TO CONSTRUCT AN EMERGENCY BRIDGE

WHEN A RAINSTORM WASHED OUT AN IMPORTANT THOROUGHFARE

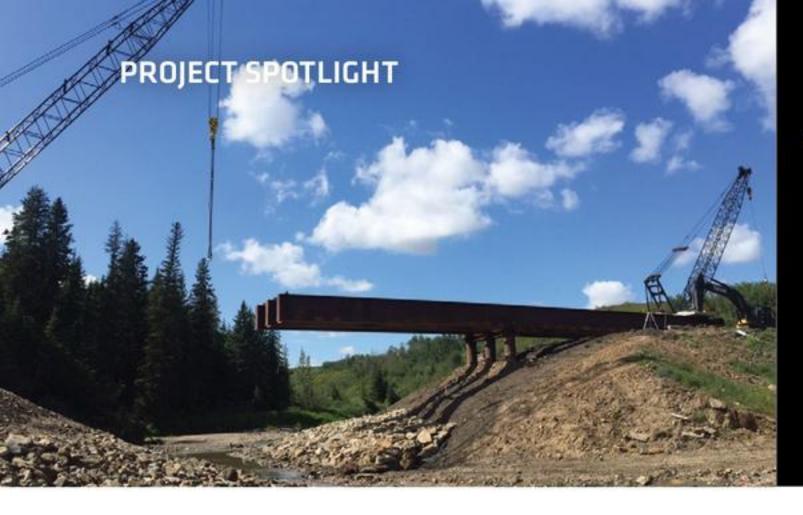
"This was not a cookie cutter part of the project. We needed to put a lot of engineering and logistics into place to ensure [girders] got there safely."

- Phil Toma, Formula Contractors

A bigger challenge was transporting the 36.5-metre girders from Chetwynd, B.C. to Dawson, about an hour's drive. Due to their length, the three bridge girders and associated bracing had to be transported to the Rolla Road site through Dawson Creek using a transport truck and rear steering dolly configuration.

Dawson Creek has a roundabout, which made moving the oversized load a challenge.

"This was not a cookie cutter part of the project," said Toma. "We needed to put a lot of engineering and logistics into place to ensure it got there safely."
